Experiment #1 Part A

Purpose: Gain an understanding of the peripheral addressing on the CME11E9-EVBU development board for use in a PAL22V10 .PLD file for programming an address decoder chip.

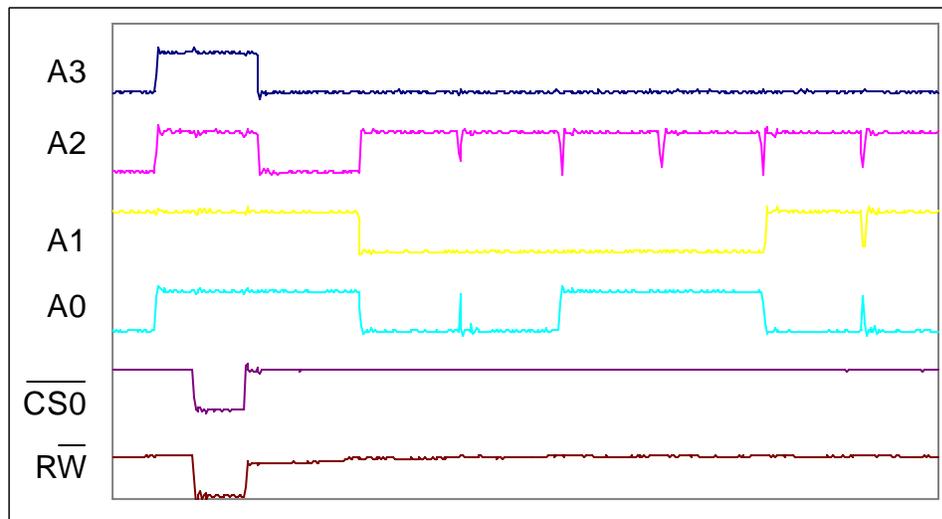
Results: The following waveforms were obtained:

Data in file: addr-fluke-1.xls

Conclusions: For the write to address \$B58F us the logic equation

$$Adr = NOT(\overline{RW}) \& NOT(\overline{CS0}) \& A0 \& A1 \& A2 \& A3$$

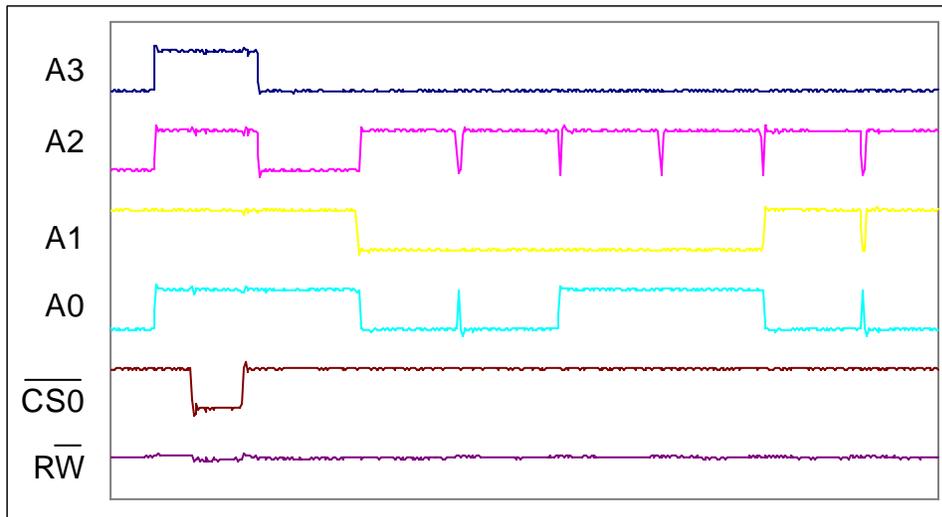
Results: Using an oscilloscope , the following waveforms were obtained:

Data in file: addr-fluke-1.xls

*note: RW was always HIGH

Conclusions: To read from address \$B58F us the logic equation

$$Adr = \overline{RW} \& NOT(\overline{CS0}) \& A0 \& A1 \& A2 \& A3$$

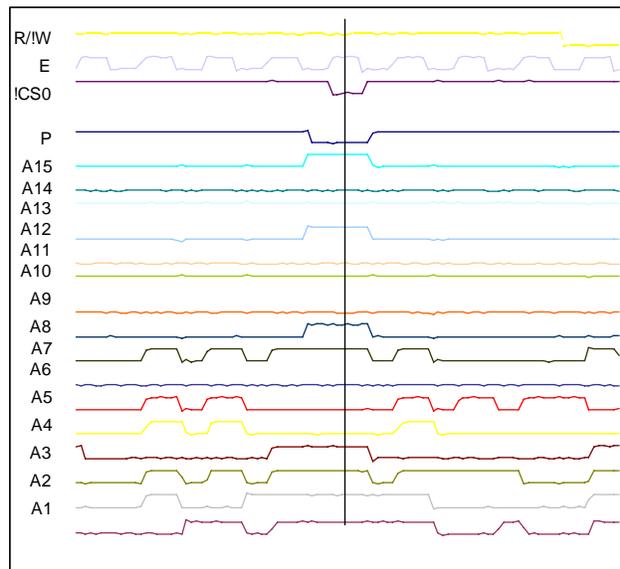
Results: Using an oscilloscope, the following waveforms were obtained:

Data in file: addr-fluke-2.xls

Conclusions: As show with the vertical line in the graph above, A0..A15 contain the address \$B58F during the LDAA \$B58F instruction, R/W is High, P is LOW and E is High. This produces a LOW on CS0.

Addressing for lines A15..A7 is taken care of by ATF16V8B on Axiom Board (with P as the output. P is then used along with A4..A6, AS, and E to produce CS0 using the 74HC138 again on the axiom board.

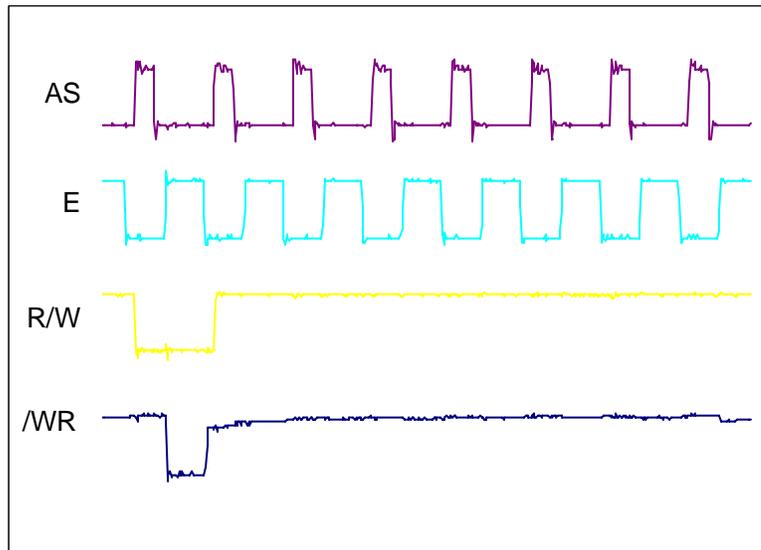
Results: Using an oscilloscope , the following waveforms were obtained:

Data in file: fluke-3.xls

Conclusions: By referencing the schematic of the Development board, it is noted that the R/W signal is coming directly from the 68HC11, while the /WR is coming from U2. /WR seems to be used as a write enable for the EEPROM and therefore should NOT be used for the addressing of the Expanded I/O Card. **R/W should be used for Expanded I/O Card addressing [BUS_PORT PIN 35].**

NOTE: Up till this point all tests used the WRONG PIN for the R/W signal (IE they used the /WR pin [Bus_port pin 25]).

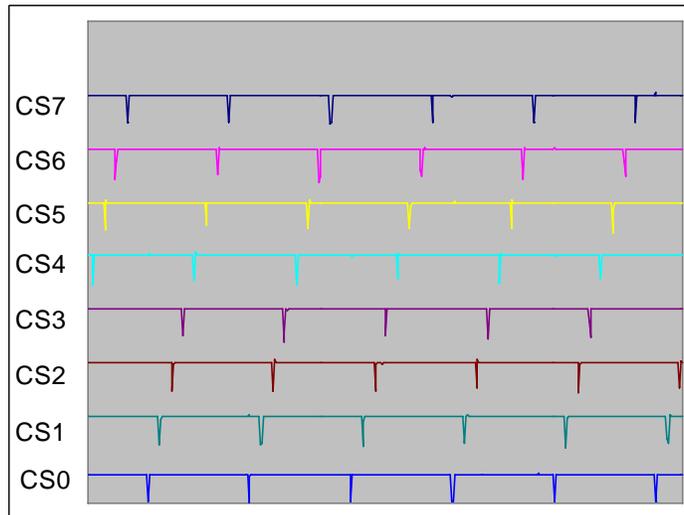
Results: Using an oscilloscope , the following waveforms were obtained:

Data in file: fluke-3.xls

Conclusions: This proves that all the CS lines ARE ACTIVE LOW and that address \$B5F0 does effect CS7.

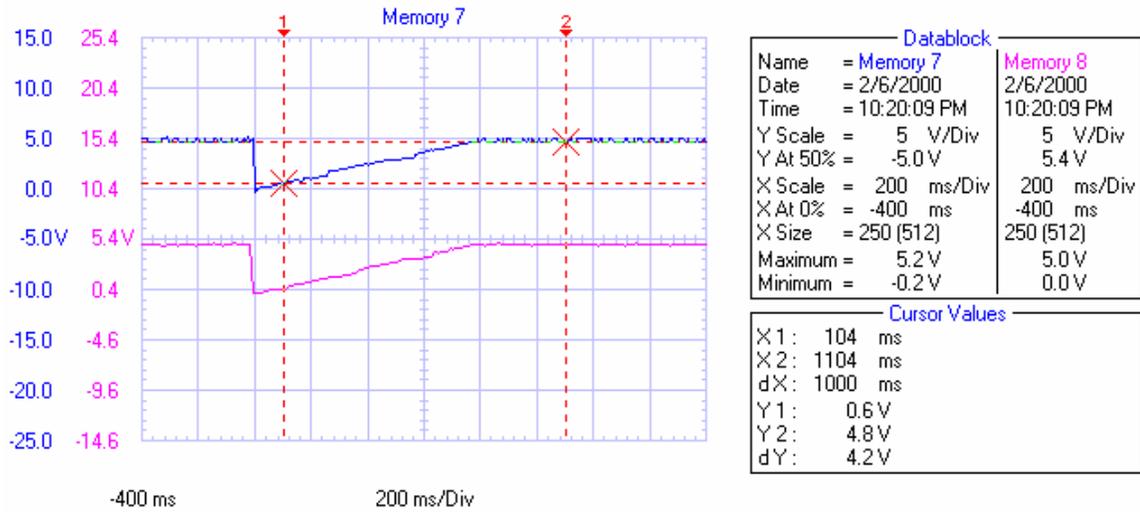
2) Using the above program, the results were again as expected. Both outputs A and B were the same, and both showed a ramp as the software counted from 0 to 254. The output remained at near +5v when the program stopped execution. The following graph is the waveform produced:

$$V_{out} = (byte_sent / 255) * V_{ref}$$
